Re: Application of Dattilo Family Holdings, LLC for Amendment to Regulated Activities Permit No. 316, for work associated with construction of 38 Rental Apartments, 26 Kirtland Street and Surrounding Parcels, Westbrook, CT, "Dattilo Village" – Phase I Assessment of 32 Kirtland Street, Westbrook, CT

28 APRIL 2021
File No. 1804-01

SUMMARY OF PHASE I FINDINGS - 32 KIRTLAND STREET, WESTBROOK, CONNECTICUT

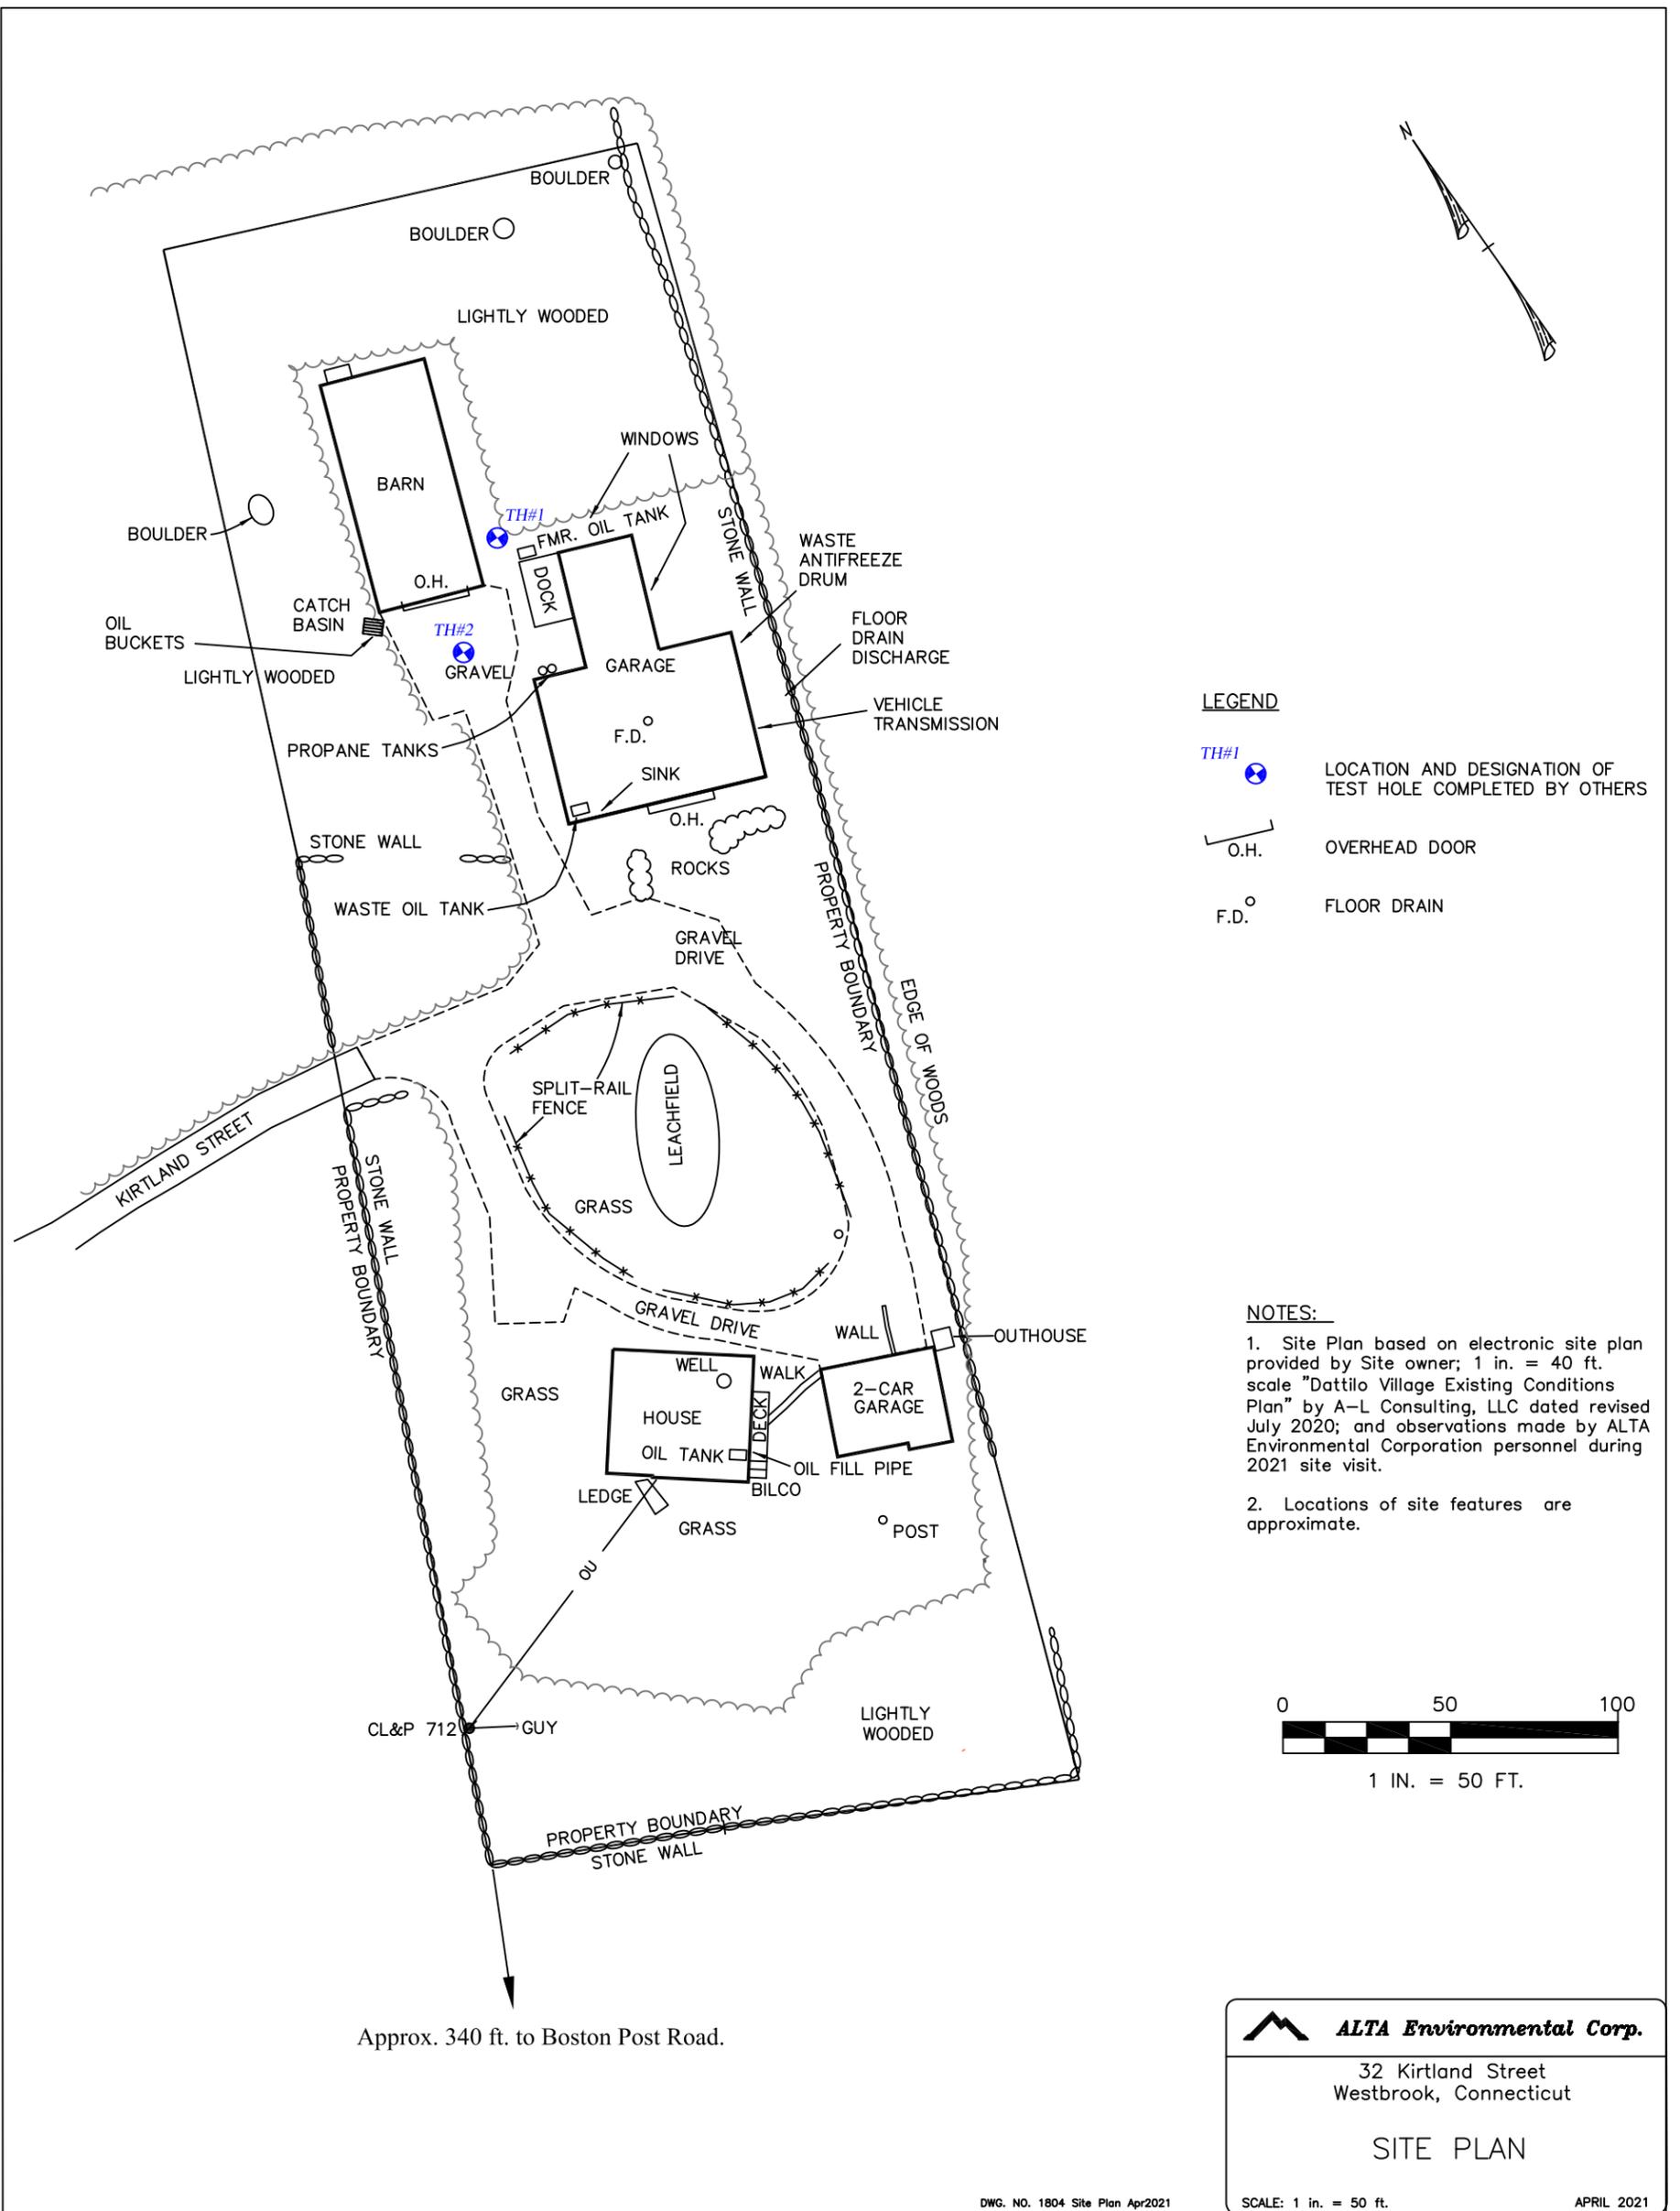
Figure 1

- Fuel oil AST formerly located off northwest corner of garage building as shown on Site plan; unknown removal date. Oily staining was not observed on the ground surface at the former AST locations, however the ground surface appeared to have been disturbed and may not be representative of conditions when the AST was present. Although the condition of the former fuel oil AST was not observed by ALTA and the ground surface was not stained at the time of ALTA's Site visit, ALTA considers the former fuel oil AST to be an area of concern due to the potential of a former release.
